**Flood Control Project Maintenance
Levee Inspections****LMA District Cover Sheet
Spring 2015 Levee Inspection Results****Sutter Maintenance Yard Hamilton Bend**

Spring 2015 Levee Inspection Results

Sutter Maintenance Yard Hamilton Bend

Waterway			Bank	Unit Miles
Unit No. 01 Feather River Hamilton Bend			Right	3.39
	Spring (March - May)	Summer (June - August)	(September - November) Fall	Winter (December - February)
Unit Maintenance Rating (Fall Only)				
Date of Inspection	04/27/2015 - 04/27/2015			
DWR Inspector	Michael Pitta			
Accompanied By

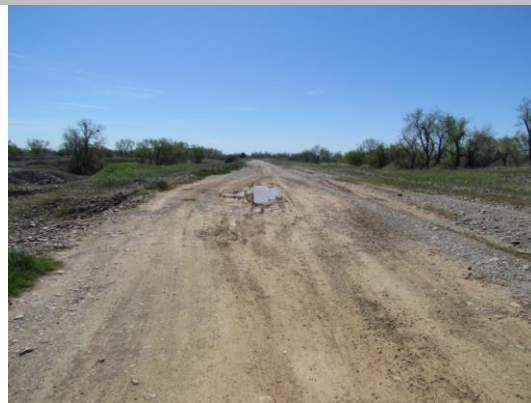
Photo 1 of 1 : SP_2015_ST0005_289_12_20150401_00004.jpg

This photo was taken from the levee crown facing north looking at crown surface depressions caused by vehicle traffic. Spring 2014.

LM Start	0.37	Rating **	M	Issue No.	12
LM End	0.37	Issue Type +	Ma	Location *	CR
Category	Earthen Levee			GPS Latitude/Longitude	
				Start	End
Item	Crown Surface / Depressions / Rutting			39.445008 °	39.445008 °
				-121.641811 °	-121.641812 °
DWR ID	DWR_ST0005_01_s _ 2014_12				
Action/Comments					
Repair depressions or ruts in the crown or slope.

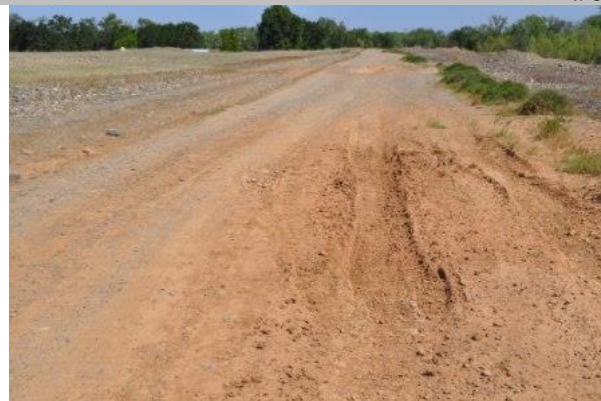
Photo 1 of 1 : SP_2015_ST0005_289_2_20150401_00001.jpg

Deep rut in crown. Repair prior to flood season.

LM Start	0.40	Rating **	M	Issue No.	2
LM End	0.40	Issue Type +	Ma	Location *	CR
Category	Earthen Levee			GPS Latitude/Longitude	
				Start	End
Item	Crown Surface / Depressions / Rutting			39.445420 °	39.445430 °
				-121.641809 °	-121.641802 °
DWR ID	DWR_ST0005_01_s _ 2015_2				
Action/Comments					
Add appropriate material and re-grade the levee to bring the crown above the design elevation.

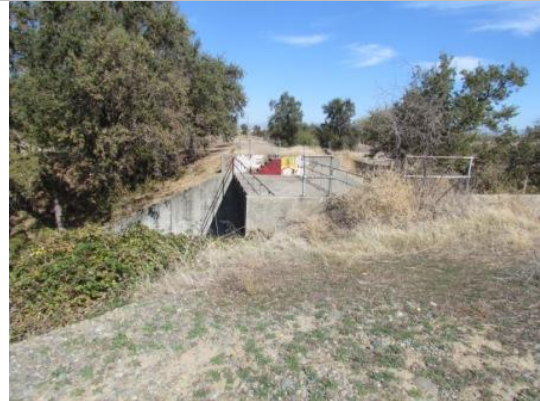
Photo 1 of 1 : SP_2015_ST0005_289_28_20150401_00005.jpg

LM Start	1.05	Rating **	A/W	Issue No.	28
LM End	1.05	Issue Type +	En	Location *	CR
Category	Earthen Levee			GPS Latitude/Longitude	
				Start	End
Item	Encroachments			39.454485 °	39.454485 °
				-121.640309 °	-121.640309 °
DWR ID	DWR_ST0005_01_f_2013_28				
Action/Comments					
Building					
Inspector Comments: Abandoned inlet structure.

This photo was taken facing north looking down the levee crown at an old inlet structure. Fall 2013.

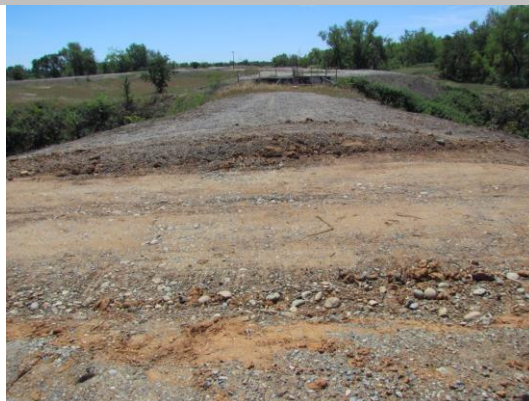
Photo 1 of 2 : SP_2015_ST0005_289_18_20150429_00011.jpg

View of the depression on the crown facing downstream.

LM Start	1.08	Rating **	U	Issue No.	18
LM End	1.08	Issue Type +	Ma	Location *	CR
Category	Earthen Levee			GPS Latitude/Longitude	
				Start	End
Item	Crown Surface / Depressions / Rutting			39.454935 °	39.454935 °
				-121.640097 °	-121.640097 °
DWR ID	DWR_ST0005_01_s _ 2015_18				
Action/Comments					
Repair depressions or ruts in the crown or slope.

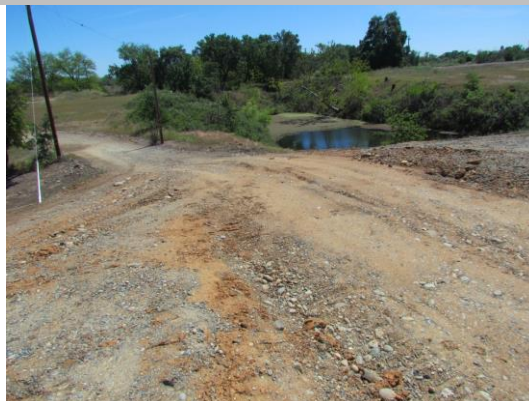
Photo 2 of 2 : SP_2015_ST0005_289_18_20150429_00012.jpg

View of the depression on the crown facing the waterside of the levee.

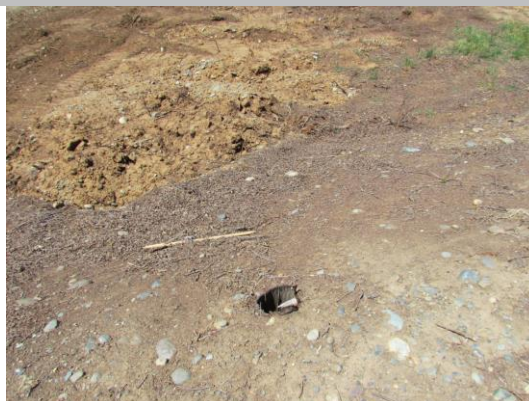
Photo 1 of 1 : SP_2015_ST0005_289_19_20150429_00014.jpg

LM Start	1.08	Rating **	U	Issue No.	19
LM End	1.08	Issue Type +	En	Location *	LS
Category	Earthen Levee			GPS Latitude/Longitude	
				Start	End
Item	Encroachments			39.454935 °	39.454935 °
				-121.640097 °	-121.640097 °
DWR ID	DWR_ST0005_01_s _ 2015_19				
Action/Comments					
Pole					
Inspector Comments: Decayed pole has left a deep hole in the levee.

View of the pole on the landside of the levee facing upstream. The pole is hollow and appears to be very deep.

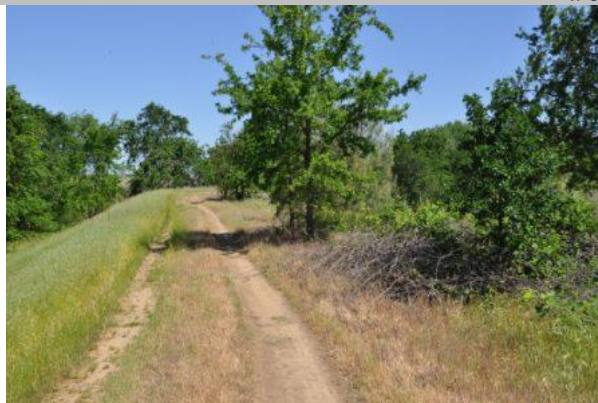
Photo 1 of 1 : SP_2015_ST0005_289_5_20150401_00003.jpg

W/S trees.

LM Start	1.51	Rating **	M	Issue No.	5
LM End	1.69	Issue Type +	Ma	Location *	WS
Category	Earthen Levee			GPS Latitude/Longitude	
				Start	End
Item	Trim / Thin Trees			39.458255 °	39.459451 °
				-121.635808 °	-121.633670 °
DWR ID	DWR_ST0005_01_s _ 2013_5				
Action/Comments					
Trim and thin trees to allow visibility of the ground and room to flood fight.
